ASBESTOS MANAGEMENT SURVEY

61 Yarmouth Crescent, London, N17 9PQ

9 Feb 2026

J1951

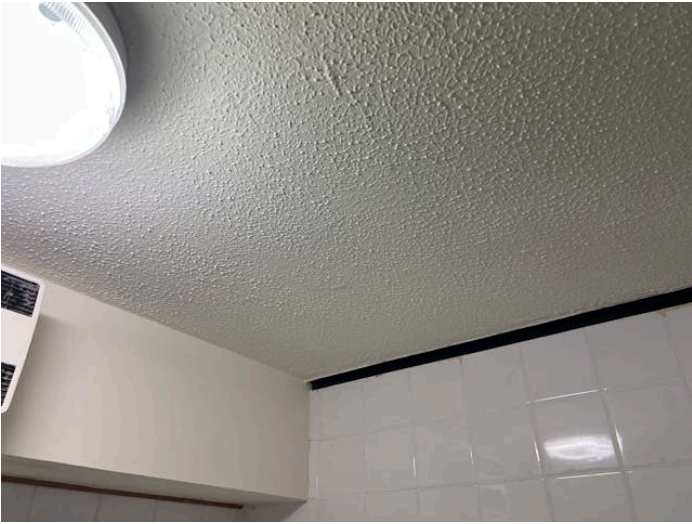
Main Building > 2 > Bathroom > Decorative finish

Building	Main Building	Level	2
Location	Bathroom	Item	Decorative finish
Material	Textured coating	Extent	2 m2

Strategy / Sample Id	Strongly Presume / 01	Presumed Fibre Type	Chrysotile
Recommendation	Manage and annually re-inspect		
General Comments	Textured coating to ceiling.

Product Type (or Debris from Product)	1	Extent of Damage / Deterioration	0
Surface Type / Treatment	1	Asbestos Type	1
Material Score	3 / Very Low

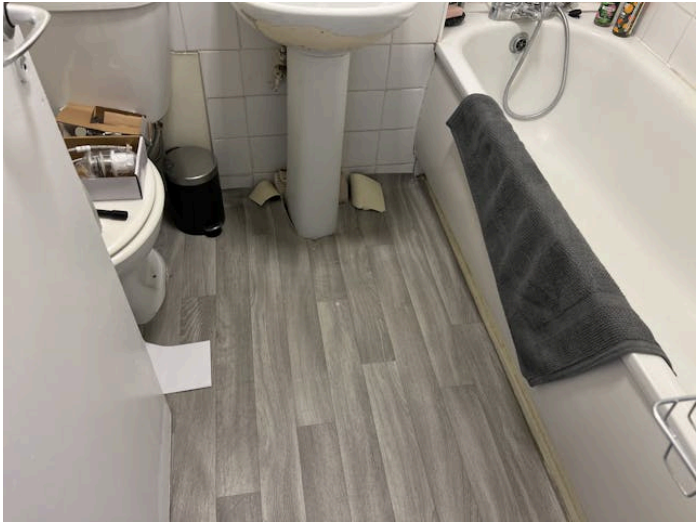
Main Building > 2 > Bathroom > Flooring

Building	Main Building	Level	2
Location	Bathroom	Item	Flooring
Material	Tiles and adhesive	Extent	3m2

Strategy / Sample Id	Strongly Presume / 03	Presumed Fibre Type	Chrysotile
Recommendation	Manage and annually re-inspect.		
General Comments	Tiles and adhesive to concrete floor.

Product Type (or Debris from Product)	1	Extent of Damage / Deterioration	1
Surface Type / Treatment	1	Asbestos Type	1
Material Score	4 / Very Low

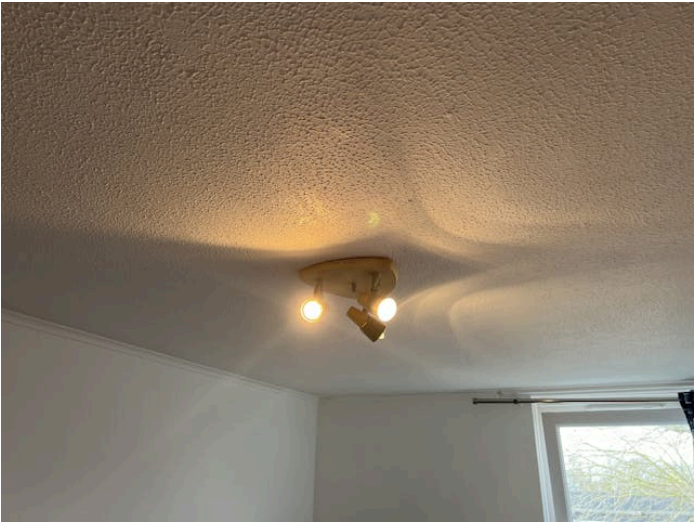
Main Building > 2 > Bedroom > Decorative finish

Building	Main Building	Level	2
Location	Bedroom	Item	Decorative finish
Material	Textured coating	Extent	14 m2

Strategy / Sample Id	Strongly Presume / 01	Presumed Fibre Type	Chrysotile
Recommendation	Manage and annually re-inspect		
General Comments	Textured coating to ceiling.

Product Type (or Debris from Product)	1	Extent of Damage / Deterioration	0
Surface Type / Treatment	1	Asbestos Type	1
Material Score	3 / Very Low

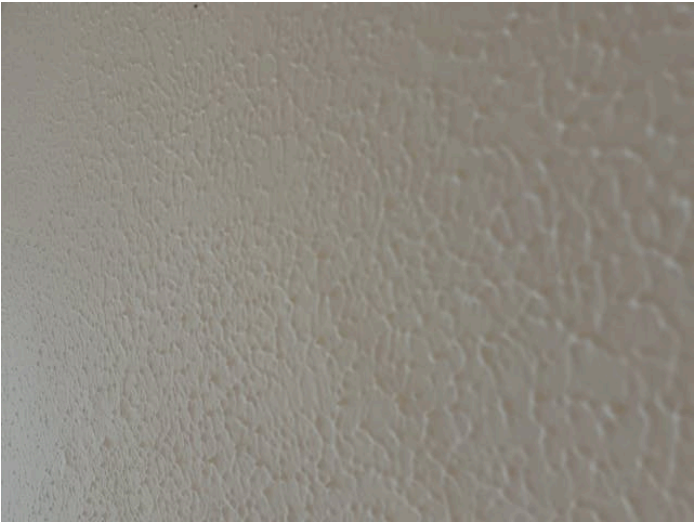
Main Building > 2 > Cupboard 1 > Decorative finish

Building	Main Building	Level	2
Location	Cupboard 1	Item	Decorative finish
Material	Textured coating	Extent	1m2

Strategy / Sample Id	Strongly Presume / 01
Recommendation	Manage and annually re-inspect		
General Comments	Textured coating to ceiling.

Product Type (or Debris from Product)	1	Extent of Damage / Deterioration	0
Surface Type / Treatment	1	Asbestos Type	1
Material Score	3 / Very Low

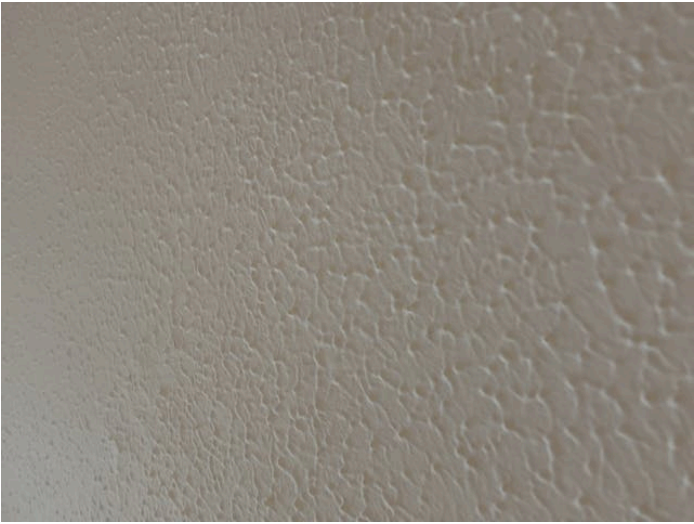
Main Building > 2 > Cupboard 2 > Decorative finish

Building	Main Building	Level	2
Location	Cupboard 2	Item	Decorative finish
Material	Textured coating	Extent	1m2

Strategy / Sample Id	Strongly Presume / 01	Presumed Fibre Type	Chrysotile
Recommendation	Manage and annually re-inspect		
General Comments	Textured coating to ceiling.

Product Type (or Debris from Product)	1	Extent of Damage / Deterioration	0
Surface Type / Treatment	1	Asbestos Type	1
Material Score	3 / Very Low

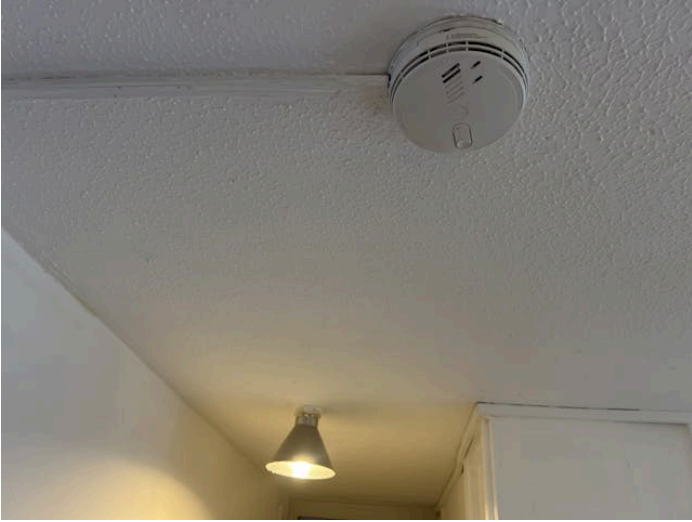
Main Building > 2 > Hall > Decorative finish

Building	Main Building	Level	2
Location	Hall	Item	Decorative finish
Material	Textured coating	Extent	5m2

Strategy / Sample Id	Sample / 01	Fibre Type	Chrysotile
Recommendation	Manage and annually re-inspect		
General Comments	Textured coating to ceiling.

Product Type (or Debris from Product)	1	Extent of Damage / Deterioration	0
Surface Type / Treatment	1	Asbestos Type	1
Material Score	3 / Very Low

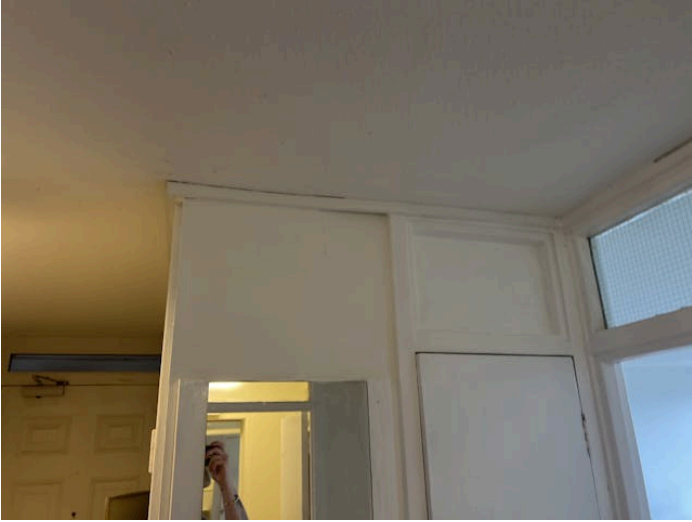
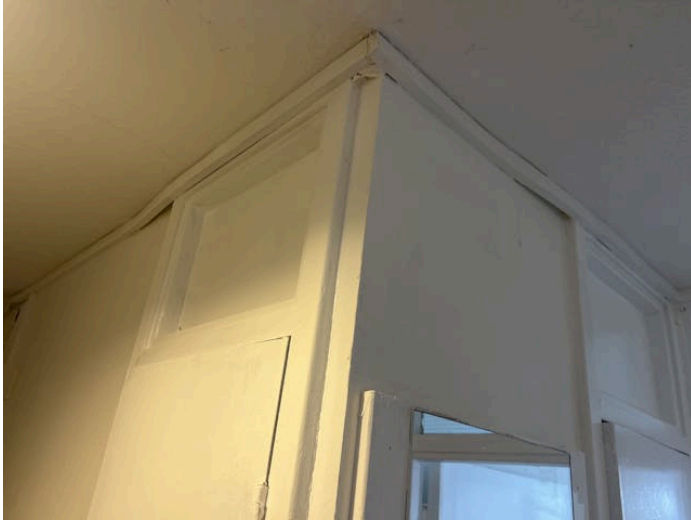
Main Building > 2 > Hall > Door headers

Building	Main Building	Level	2
Location	Hall	Item	Door headers
Material	Insulating board	Extent	X2

Strategy / Sample Id	Sample / 02	Fibre Type	Amosite
Recommendation	Manage and annually re-inspect		
General Comments	Insulating board infill panels above cuoboard doors.

Product Type (or Debris from Product)	2	Extent of Damage / Deterioration	0
Surface Type / Treatment	1	Asbestos Type	2
Material Score	5 / Low

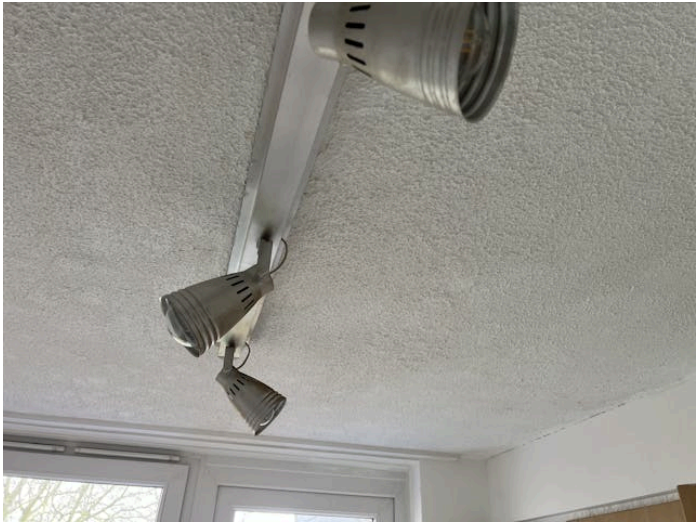
Main Building > 2 > Kitchen > Decorative finish

Building	Main Building	Level	2
Location	Kitchen	Item	Decorative finish
Material	Textured coating	Extent	8 m2

Strategy / Sample Id	Strongly Presume / 01	Presumed Fibre Type	Chrysotile
Recommendation	Manage and annually re-inspect		
General Comments	Textured coating to ceiling.

Product Type (or Debris from Product)	1	Extent of Damage / Deterioration	0
Surface Type / Treatment	1	Asbestos Type	1
Material Score	3 / Very Low

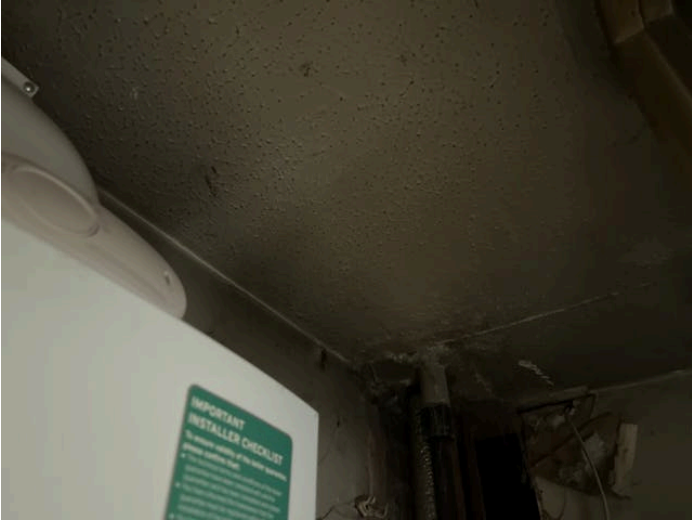
Main Building > 2 > Kitchen cupboard > Decorative finish

Building	Main Building	Level	2
Location	Kitchen cupboard	Item	Decorative finish
Material	Textured coating	Extent	3 m2

Strategy / Sample Id	Strongly Presume / 01	Presumed Fibre Type	Chrysotile
Recommendation	Manage and annually re-inspect		
General Comments	Textured coating to ceiling.

Product Type (or Debris from Product)	1	Extent of Damage / Deterioration	0
Surface Type / Treatment	1	Asbestos Type	1
Material Score	3 / Very Low

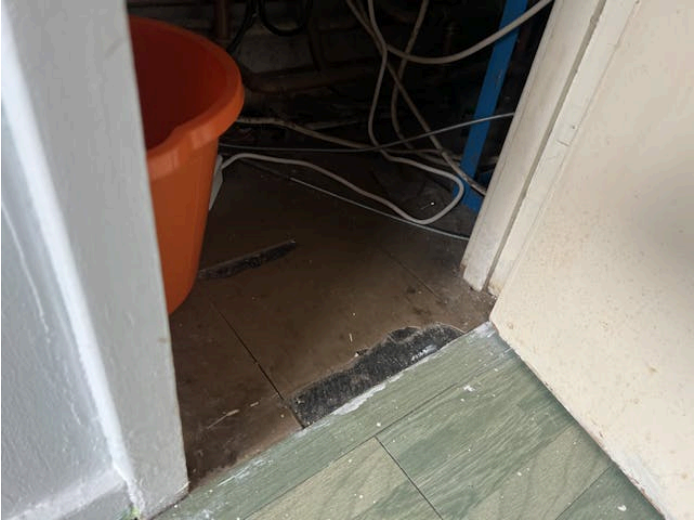
Main Building > 2 > Kitchen cupboard > Flooring

Building	Main Building	Level	2
Location	Kitchen cupboard	Item	Flooring
Material	Tiles and adhesive	Extent	3m2

Strategy / Sample Id	Sample / 03	Fibre Type	Chrysotile
Recommendation	Manage and annually re-inspect.		
General Comments	Tiles and adhesive to concrete floor.

Product Type (or Debris from Product)	1	Extent of Damage / Deterioration	1
Surface Type / Treatment	1	Asbestos Type	1
Material Score	4 / Very Low

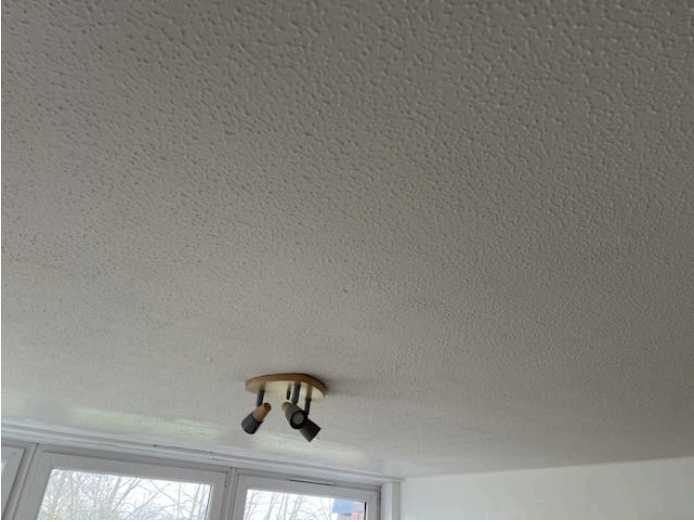
Main Building > 2 > Lounge > Decorative finish

Building	Main Building	Level	2
Location	Lounge	Item	Decorative finish
Material	Textured coating	Extent	14m2

Strategy / Sample Id	Strongly Presume / 01	Presumed Fibre Type	Chrysotile
Recommendation	Manage and annually re-inspect		
General Comments	Textured coating to ceiling.

Product Type (or Debris from Product)	1	Extent of Damage / Deterioration	0
Surface Type / Treatment	1	Asbestos Type	1
Material Score	3 / Very Low

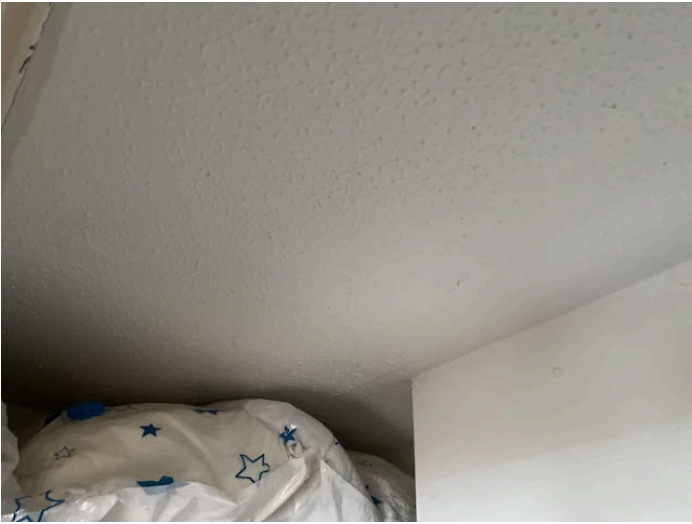
Main Building > 2 > Lounge cupboard > Decorative finish

Building	Main Building	Level	2
Location	Lounge cupboard	Item	Decorative finish
Material	Textured coating	Extent	2 m2

Strategy / Sample Id	Strongly Presume / 01	Presumed Fibre Type	Chrysotile
Recommendation	Manage and annually re-inspect		
General Comments	Textured coating to ceiling.

Product Type (or Debris from Product)	1	Extent of Damage / Deterioration	0
Surface Type / Treatment	1	Asbestos Type	1
Material Score	3 / Very Low
