ASBESTOS MANAGEMENT SURVEY

61 Yarmouth Crescent, London, N17 9PQ

9 Feb 2026

J1951

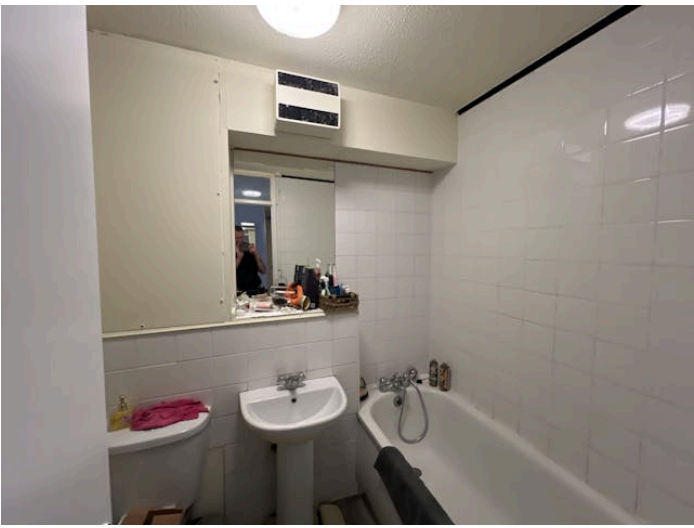
Building	Main Building	Level	2
Location	Bathroom	Item

Location Notes	Concrete ceiling, brick plastered walls and plasterboard lined walls,timber boxing, glass door header, fitted flooring.

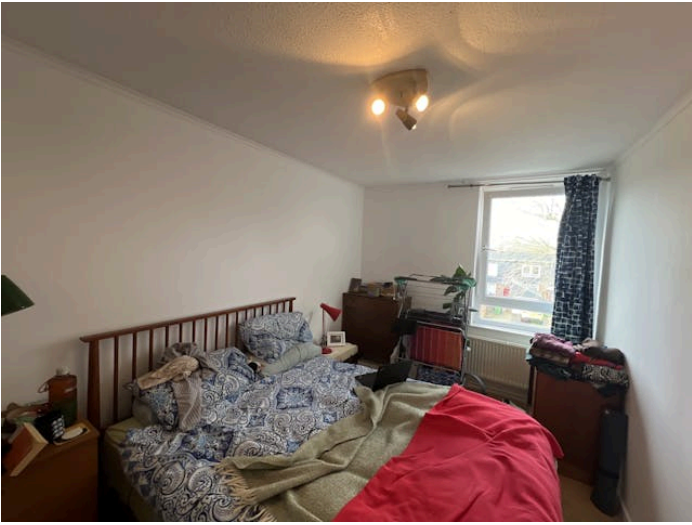
Building	Main Building	Level	2
Location	Bedroom	Item

Location Notes	Concrete ceiling, brick plastered walls and plasterboard lined walls,plasterboard boxing, glass door header, fitted flooring.

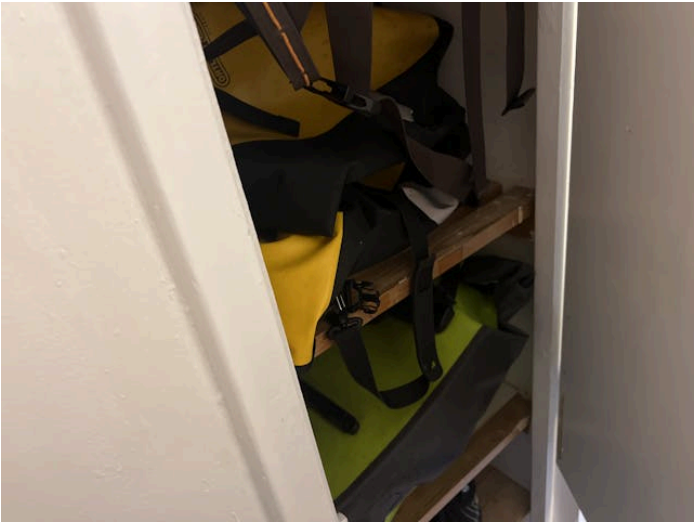
Building	Main Building	Level	2
Location	Cupboard 1	Item

Location Notes	Concrete ceiling, plasterboard lined walls, fitted flooring.

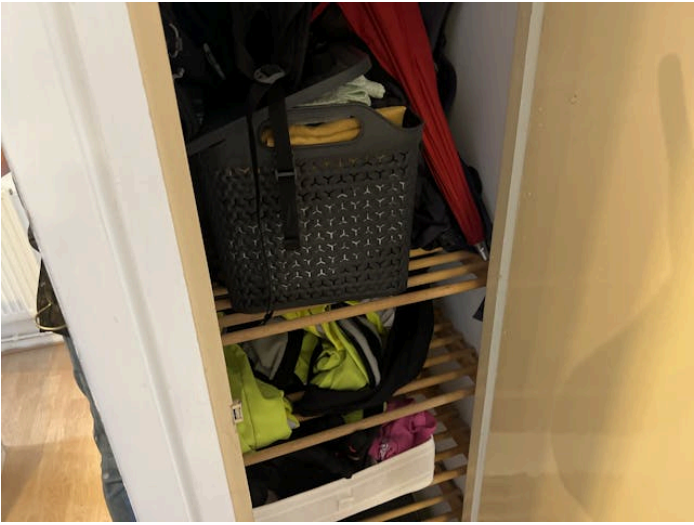
Building	Main Building	Level	2
Location	Cupboard 2	Item

Location Notes	Concrete ceiling, plasterboard lined walls, fitted flooring.

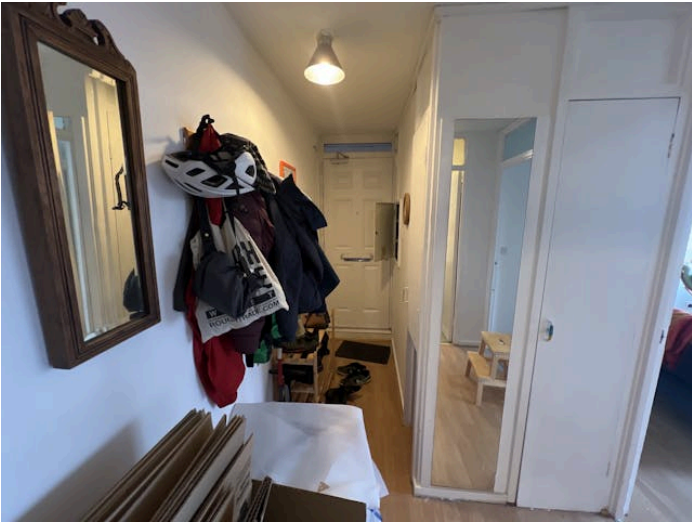
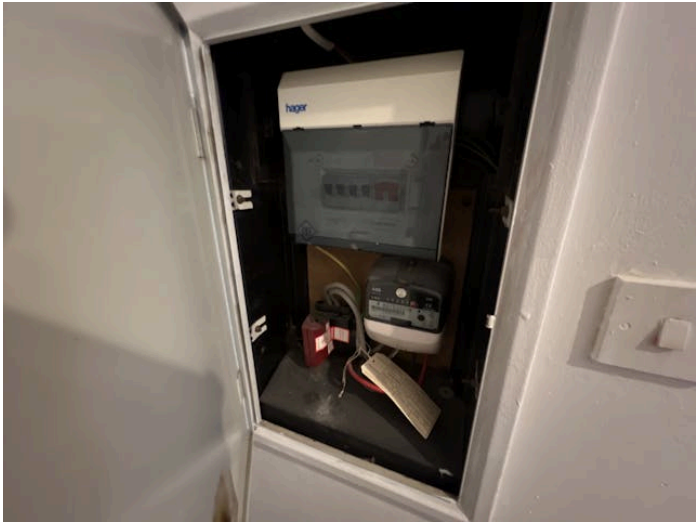
Building	Main Building	Level	2
Location	Hall	Item

Location Notes	Concrete ceiling, some glass door headers, brick plastered walls, modern electrics within tin housing, fitted flooring.

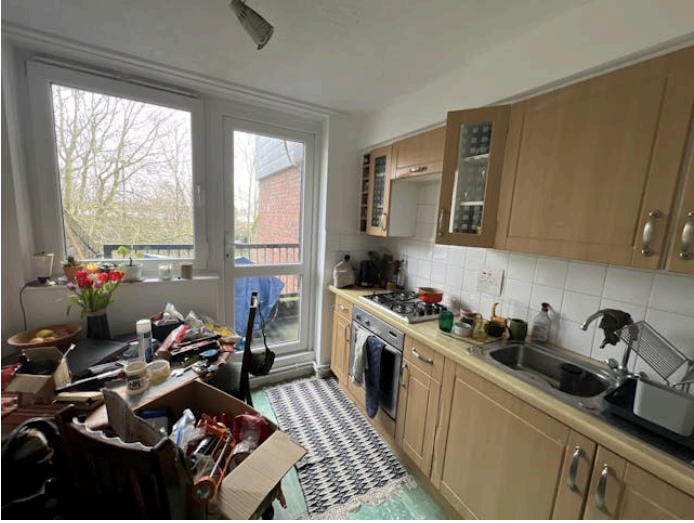
Building	Main Building	Level	2
Location	Kitchen	Item

Location Notes	Concrete ceiling, brick plastered walls and plasterboard lined walls,timber boxing and timber door headers, fitted flooring.

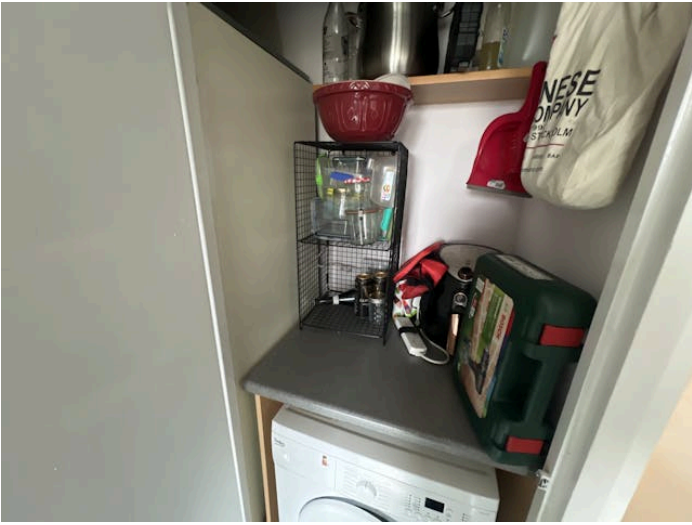
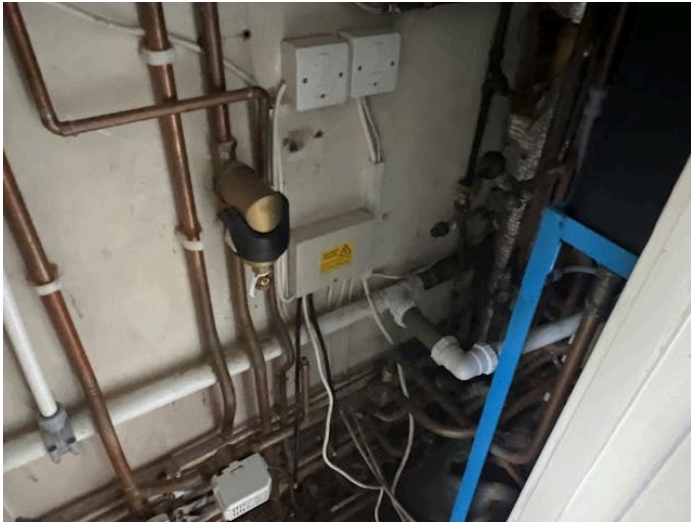
Building	Main Building	Level	2
Location	Kitchen cupboard	Item

Location Notes	Concrete ceiling, brick plastered walls and plasterboard lined walls,timber boxing and timber door headers, modern boiler and pipe work,fitted flooring.

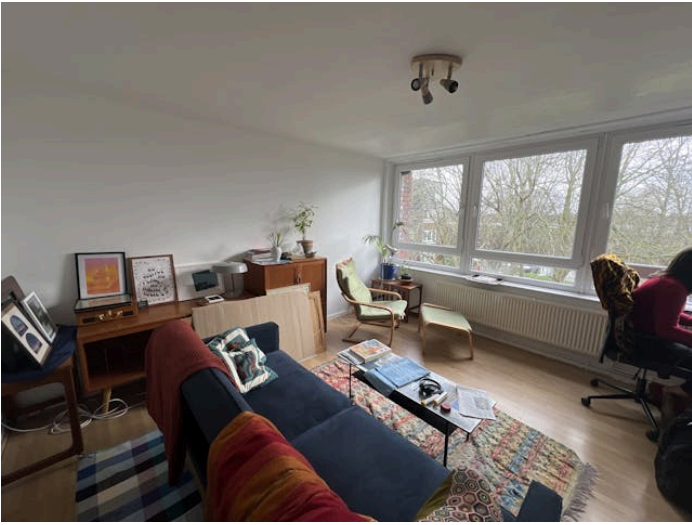
Building	Main Building	Level	2
Location	Lounge	Item

Location Notes	Concrete ceiling, brick plastered walls and plasterboard lined walls, fitted flooring.

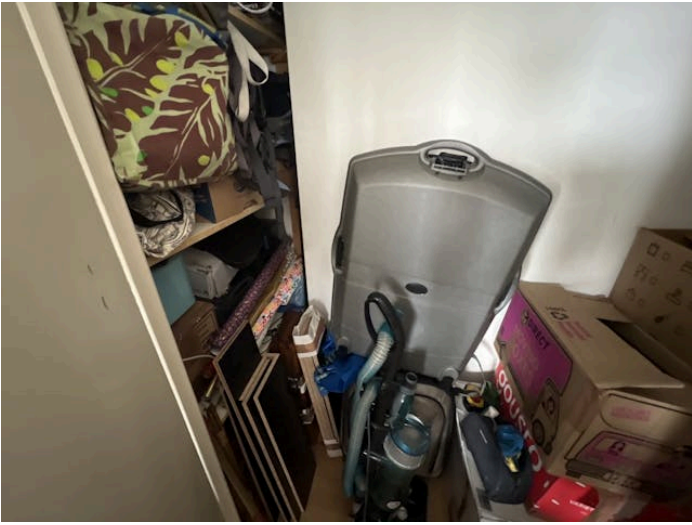
Building	Main Building	Level	2
Location	Lounge cupboard	Item

Location Notes	Concrete ceiling, brick plastered walls and plasterboard lined walls,timber door header, fitted flooring.
